Why You Should Manage, Regulate, and Partner to Eliminate Japanese Knotweed from your Community

By Brian Colleran, MS, PWS, CERP

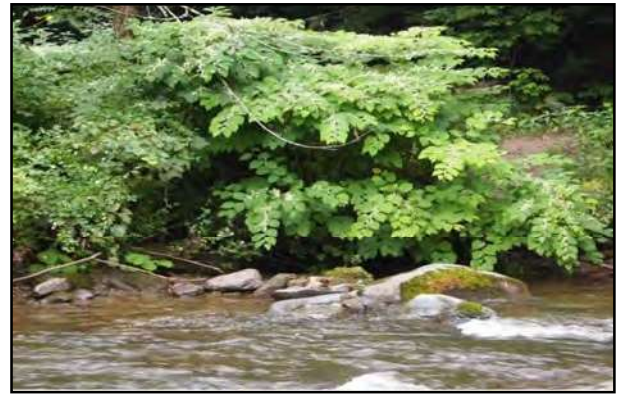
In this photo, the rocks protect the knotweed infested bank from the main current, which should both slow the water and any associated erosion. Nevertheless, there is a large hole underneath this stand of knotweed, and bank erosion continues downstream of the knotweed until the edge of the photo.

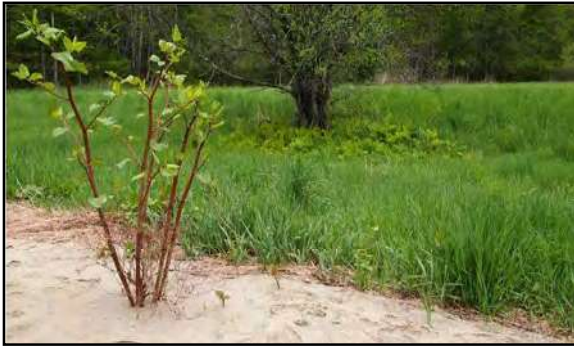
In this photo a lone knotweed deposited by Irene's floodwaters is pictured near the end of its second growing season. New shoots are already emerging from its spreading rhizomes. Following a flood, locations like these, where the flood waters deposited other debris, such as sand, are excellent places to find new knotweed. Even after two full growing seasons, plants like this can be easily removed by hand.

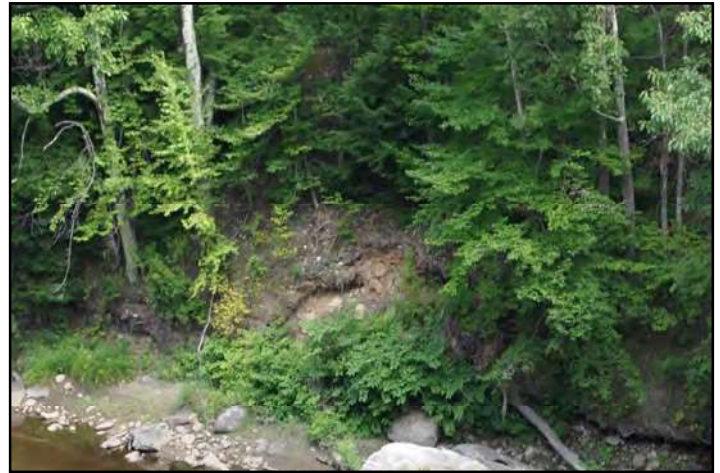
In this photo, the knotweed stand has slid downhill. The surrounding vegetation is strongly rooted on this slope, while the knotweed's underground rhizomes are not strong enough to have prevented this downhill slide.
